## Fish Out Of Water: Amphicar 770

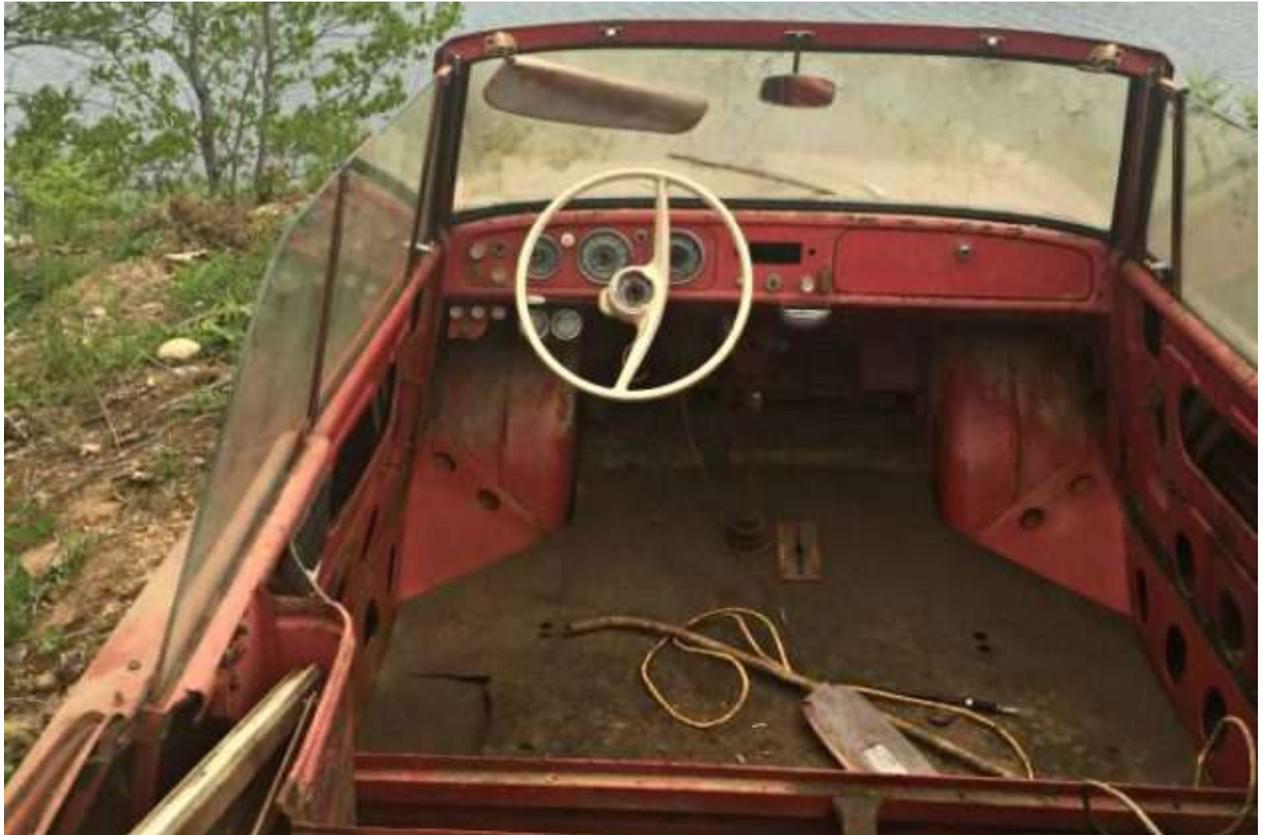
Quite bare from the interior stand point, the interior sheet metal appears rust and rot free which is definitely a good sign. I am curious about the floors and undercarriage, due to obvious reasons. These cars are prime candidates to be complete rust buckets, so this Canadian seems strange to appear as reasonable as it does. It would be fabulous if the seller had more parts to include with the car as it almost appears that the car was dismantled in such a way as if someone was going to do a restoration. All of the glass in place, and the convertible top frame is still in place as well. The shift lever is likely still linked up to the factory transmission as the transmission is still in place.

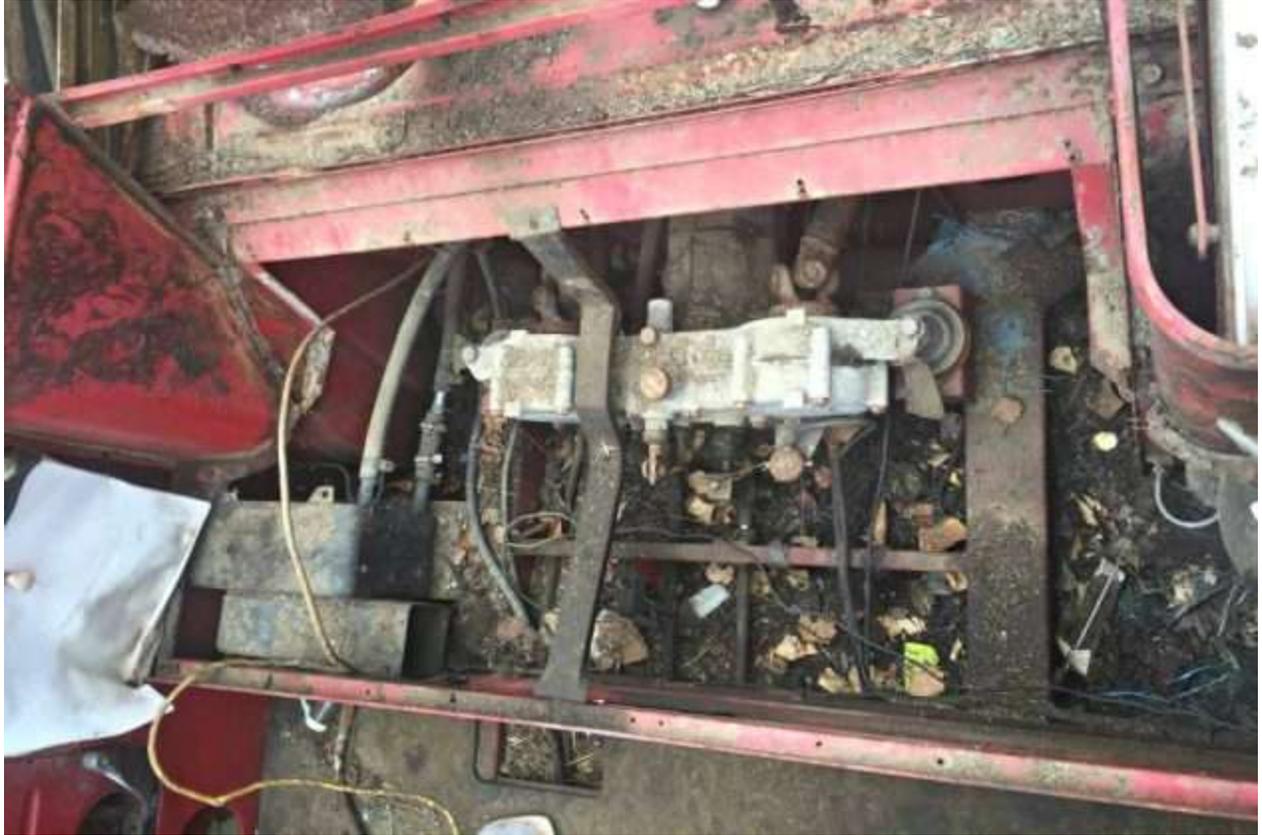
The seller has so kindly provided a picture of the unique transmission, but there is no word as to whether or not the engine is still in place. There is a fair amount of debris inside the transmission area, but the convertible top shelf and towers appear very reasonable. The worst of the damage that can be seen on this Amphicar is the driver side rear quarter. Also the rear apron is a bit rough with some small amounts of rot below each taillight. The deck lid has some rust along its sharp edges on the louvers, and along its bottom edge. There is still a muffler in place on this old fish, so perhaps the engine is still inside? Certainly an awesome project to revive, how many of you have ever taken a splash in one of these Amphicars?
